Failure analysis of a hip implant by using the FITNET fitness for service procedure

S. Cicero *, F. Gutiérrez-Solana, J.A. Álvarez, L. Sánchez

Abstract

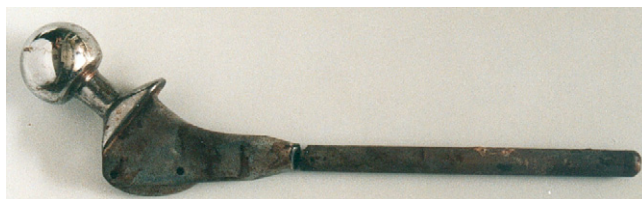
The sample, shown in Fig. 1, is a hip implant broken into two pieces. The section of the implant is circular and the diameter is 10 mm. It was extracted from the patient after its fracture. At reception, the sample was dirty with many blood traces. Also, remains of bone material were appreciated on the stem or lower part since the implant had begun to be integrated in the femur by osteointegration reactions. However, there is no presence of these bone traces in the upper part. It should be noted that the fracture surfaces, mainly the one on the lower part, were quite badly damaged due to the surgery extraction process, making the analysis more difficult.

Fig. 1. Aspect of the implant on reception.

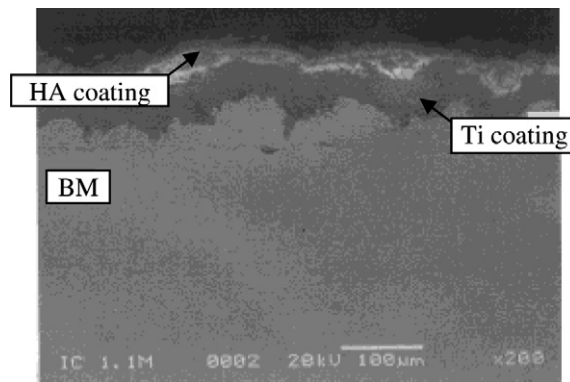
Fig. 2 shows the structure of the coatings, base material and the corresponding interphases. It is important to notice the irregularity of the coatings and the discontinuities observed in the interphase between the base material and the titanium coating, as can be clearly seen in the micrographs of Fig. 3. The micrograph in Fig. 4, which is amplified by 3500 times, shows the apparently crystalline nature of the discontinuities. They will be designated as inclusions in the base material–titanium coating interphase.

Fig. 2. General aspect of the coatings and the base material.

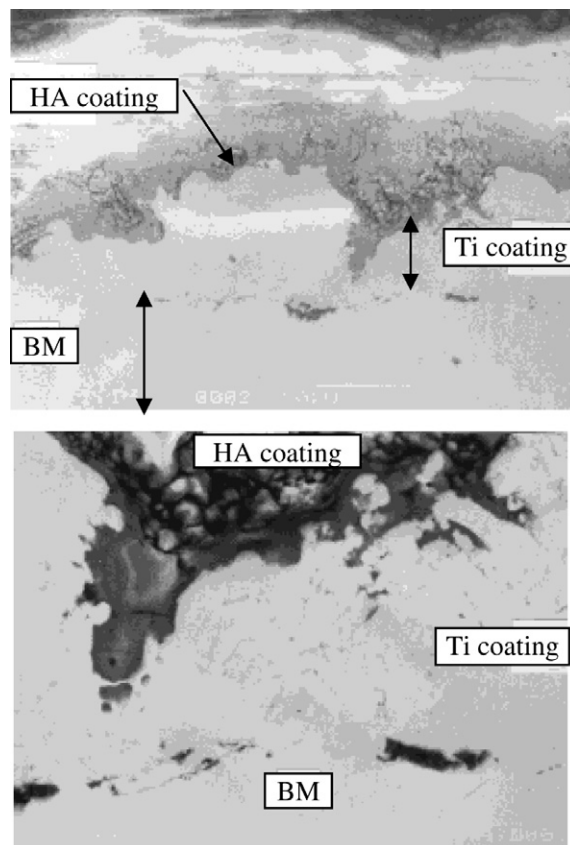
Fig. 3. Detailed image of the coatings: Ti coating varies between 10 and 100 μm . Inclusions in the interphase between base material and the titanium coating can be observed.

Table 1 shows the results of the EDS analyses. The most significant conclusion is that the base material is a Ti–Al–V alloy with bigger quantities of Al than expected for this type of alloy. Also, on the base material, there is a nearly pure titanium coating whose thickness varies between 10 and 100 μm and a HA coating with a calcium/phosphorous relation of near 1.4, slightly lower than the value of 1.67 predicted theoretically [9]. It is also worth noting the irregularity of the coatings and the discontinuities on the base material–Ti coating interphase, as shown in Fig. 3.

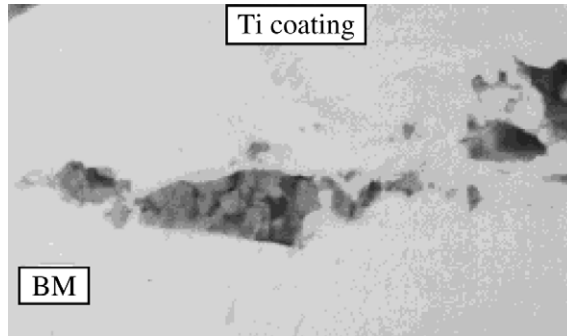
Fig. 4. Detailed image of the interphase between base material and the titanium coating, showing the clustering of alumina inclusions.

The analysis performed on the inclusions observed in the interphase between the base material and the titanium coating confirms that there were crystals of alumina inclusions (Al_2O_3). These crystals, whose size is in the order of $1\ \mu m$, are clustered and generate relatively plane areas of discontinuity which are between 5 and $20\ \mu m$ long. The inclusions can be easily identified in the above mentioned interphase since they appear as dark areas in Figs. 2–4.

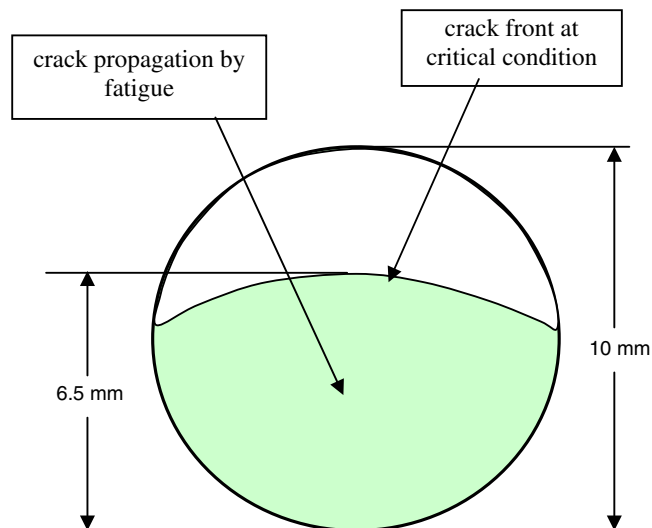
A macroscopic observation of the fracture surface allowed the fatigue growth lines of the crack to be observed. It was determined that a crack generated by fatigue reached a maximum extension of 6.5 mm. Fig. 5 shows a scheme of the fracture surface and Fig. 6 shows in a SEM micrograph the growth lines of

Fig. 5. Scheme of the crack geometry at failure.

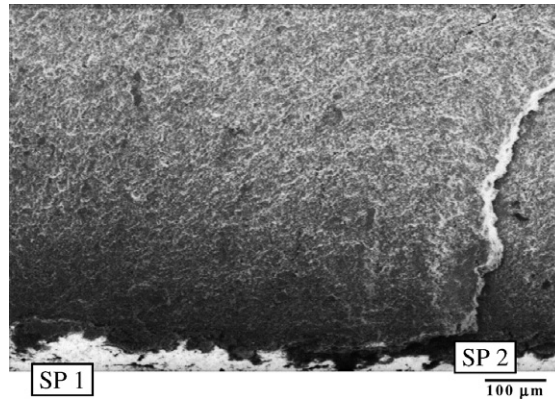
Fig. 6. Starting area of the fatigue growth with two marked starting points.

the crack, generated by fatigue, in the neighbouring area to two starting points (SP) located at both of the lower squares of the micrograph.

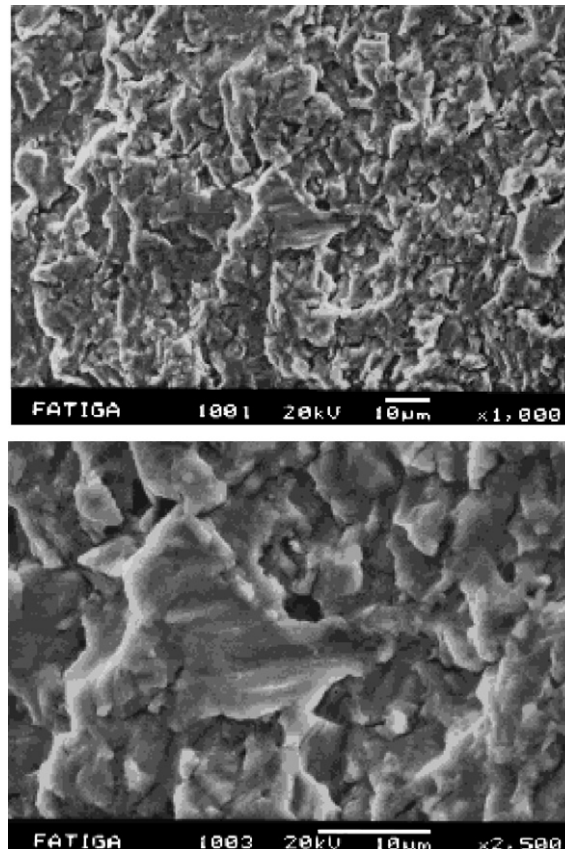
Fig. 7. Fatigue surface.

surface which is characteristic of fatigue processes in these titanium alloys [11–14]. Fig. 8, taken at 8 mm from the starting point (outside the fatigue zone), shows formation and coalescence of microvoids, which is characteristic of plastic collapse mechanisms in these materials.

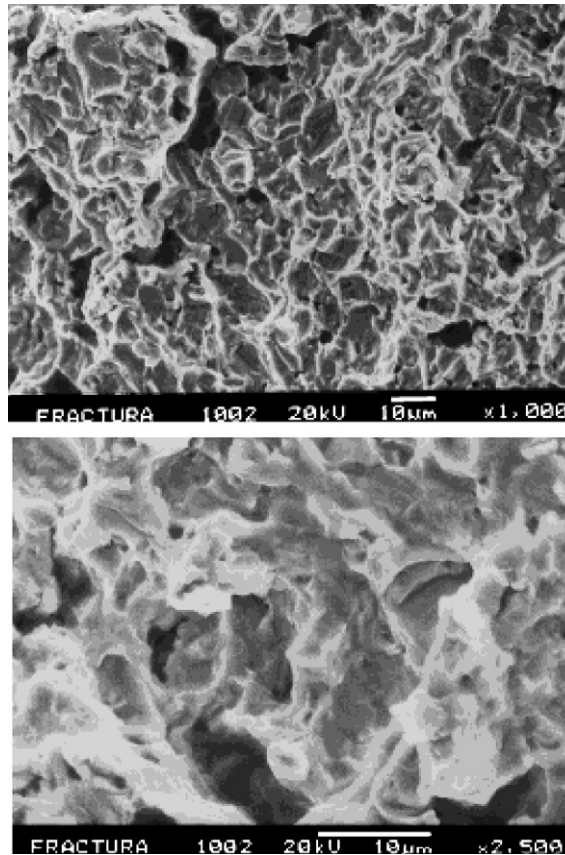
Fig. 8. Fracture surface.

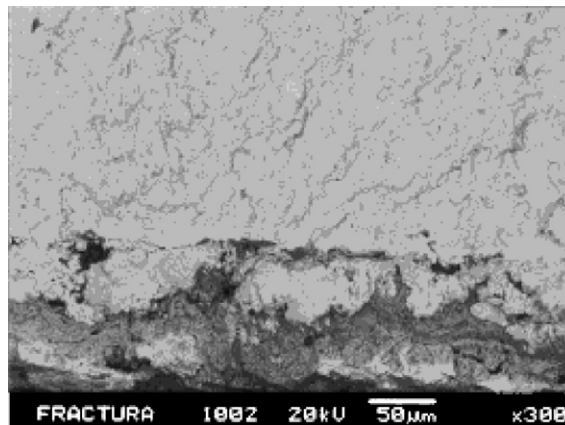
The micrographic observation of the initiation sites of the fatigue crack shows the existence of substantial disbanding, such as discontinuities in the interphase between the base material and the titanium coating. The micrograph in Fig. 9 shows that discontinuity, which is associated with the presence of a set of Al_2O_3 crystal clusters.

Fig. 9. Detailed image of the first starting point.

In both observed starting points the greater the presence of Al_2O_3 crystal clusters, the thinner the titanium coating, establishing a local notch effect on them (see Fig. 10). Initially, two crack planes propagate independently from both initiation sites for approximately 2 mm. Then, the two planes of fracture join and generate one single crack front that, after growing, established the shape and size of the final crack observed at failure.

From the results obtained, it can be noticed that failure occurred after a normal use of the implant, with no overloading. Therefore, if the same materials are used, a careful control on surface state to avoid or minimise imperfections in the interphases should be carried out.

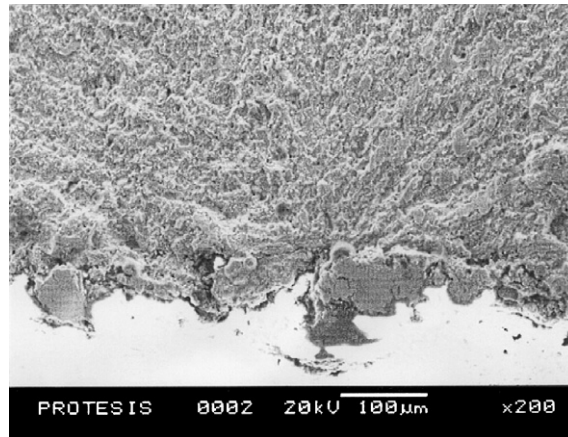
Fig. 10. Detailed image of the starting area.

From microscopy analysis, it was determined that a crack grew from an initial defect originated in the irregular coating, as shown in Figs. 2 and 3. Fig. 10 shows another micrograph of the initiation area. The defect was around 0.1 mm deep at the initial stage (the size of the irregularities located in the interphase) and 6.5 mm deep at failure, as has been shown in Fig. 5. The crack front during the propagation process is not a straight crack front or a semicircular crack front, but rather its geometry is between these two for the whole process.

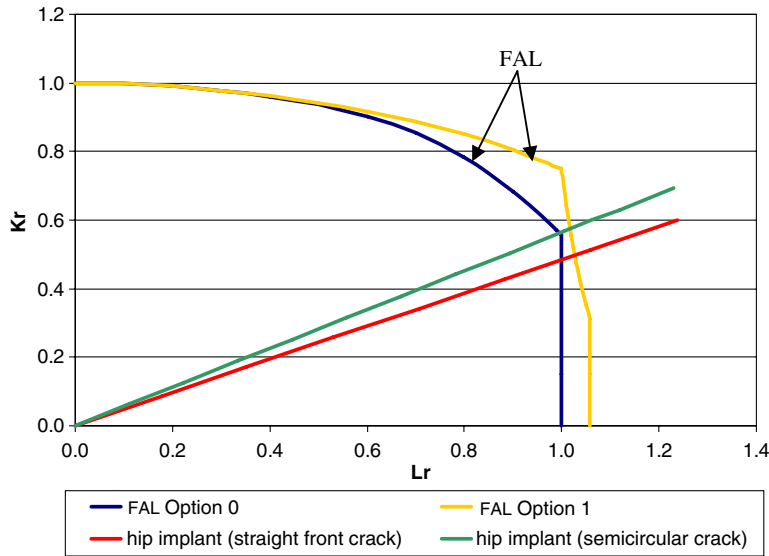
Fig. 12. Assessment of critical conditions by using FAD analysis.

Considering this solution, Fig. 12 shows the evolution of the loading conditions following the $K_r(L_r)$, being $K_r = K_I/K_{IC}$ and $L_r = P/P_L$. The intersection of the loading line $K_r(L_r)$ with the failure assessment line (FAL) defines the failure conditions, which corresponds to plastic collapse ($L_r > 1$).

Therefore, the supported load is between 0.582 kN and 0.915 kN. The actual supported load is 0.735 kN, so it can be said that the hypothesis of a crack front between straight and semicircular and peak loads of 1.0 BW is
