Failure analysis of a hip implant by using the FITNET fitness for service procedure

S. Cicero *, F. Gutiérrez-Solana, J.A. Álvarez, L. Sánchez

Abstract

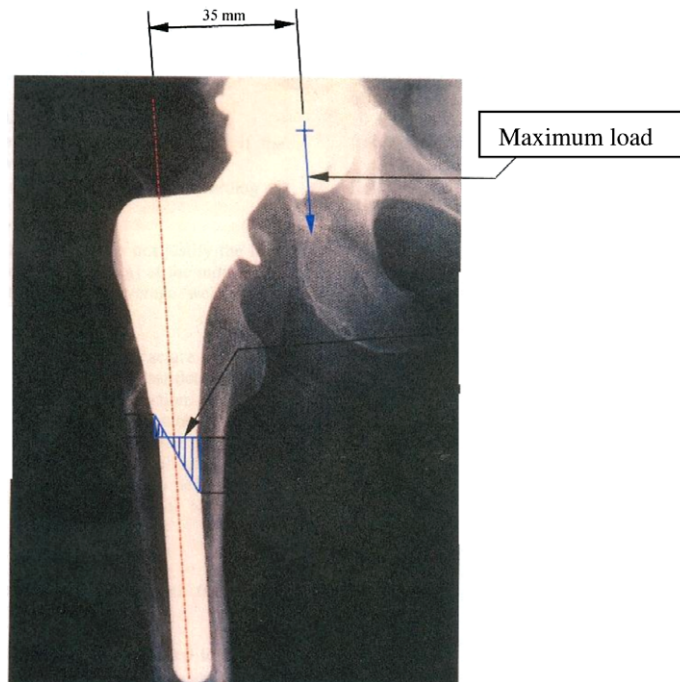
Fig. 11 presents a schema of the working conditions of the implant at failure. The implant worked as a cantilever beam, with a non-centred load applied, transmitted at the contact implant-hip bone, due to the body weight of the patient. The assumption of cantilever beam fixed up to the fracture surface is supported by the absence of adhered bone to the upper part of the piece. The direction of the load is considered to be parallel to the bone so neither shear nor torsion stresses are considered. This hypothesis is very closed to the real situation and accurate enough for the purposes of this analysis. Therefore, a mixed stress state at the ligament is achieved due to bending and compression.

At the crack front, the obtained tension stresses are responsible for the final fracture:

Fig. 11. Scheme of the working conditions.

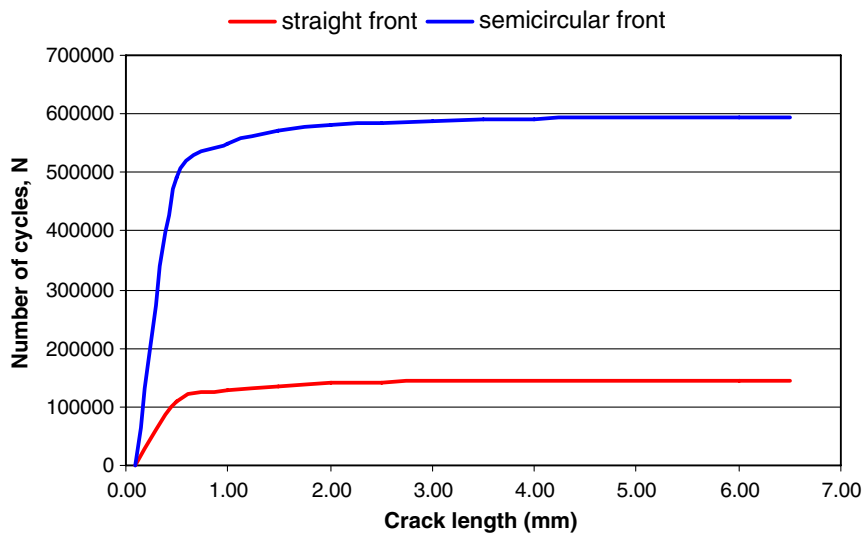
According with the conditions proposed for “normal” life (2.5 BW), the cycles obtained represent between 1.3 and 4.6 months of quick propagation before failure, depending on the crack front shape. However, the propagation under these conditions finished a few thousands of cycles before, when the patient starts to feel pain and, then, a new stage starts under new loading conditions (1.0 BW). Fig. 13 shows that wherever the quick propagation finishes, it takes around 140,000 cycles in case the crack front is straight or 500,000 cycles in case the crack front is semicircular.

Fig. 13. Crack length evolution as a function of the number of fatigue cycles.

237.600 cycles respectively. If we start to count the cycles from the end to the beginning of the process, we obtain that such numbers are the amount of cycles that are necessary for a growth from 1.5 mm to 6.5 mm (straight) or from 2.0 mm to 6.5 mm (semicircular). As a summary, a fatigue process can be suggested as follows:
